Channel Mitigation Monitoring Sheets I, II, III, AND IV

Monitoring Data Record

US 421 Site 1

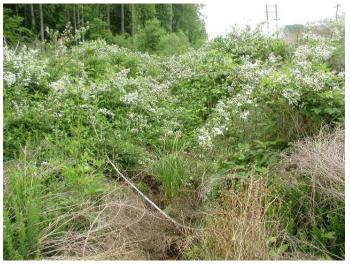
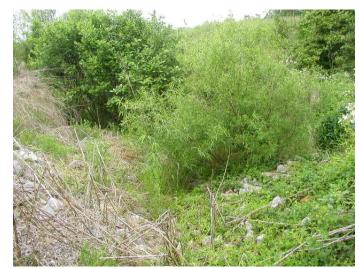
Photo 1 Photo 2

The stream is stable and is doing well for the 4th quarter of monitoring. NCDOT has completed one year
of quarterly monitoring and is requesting to discontinue visual inspection of channel stability at this site.
